# Seven Key Lessons to Prevent Worker Deaths During Hot Work In and Around Tanks

Effective Hazard Assessment and Use of Combustible Gas Monitoring Will Save Lives

No. 2009-01-SB

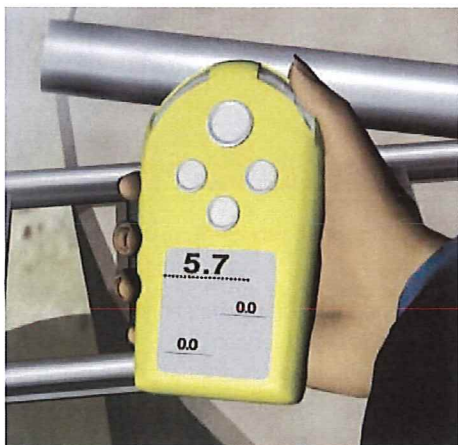
Example of a combustible gas detector used to test for the presence of flammable gas or vapor.

Flammable gas and vapor concentrations are generally determined using a portable combustible gas detector, also called an LEL<sup>3</sup> meter. Combustible gas detectors are relatively inexpensive and widely available. Training in LEL instrument use is a key component to effective gas testing and is a critical aspect of an effective hot work safety program.

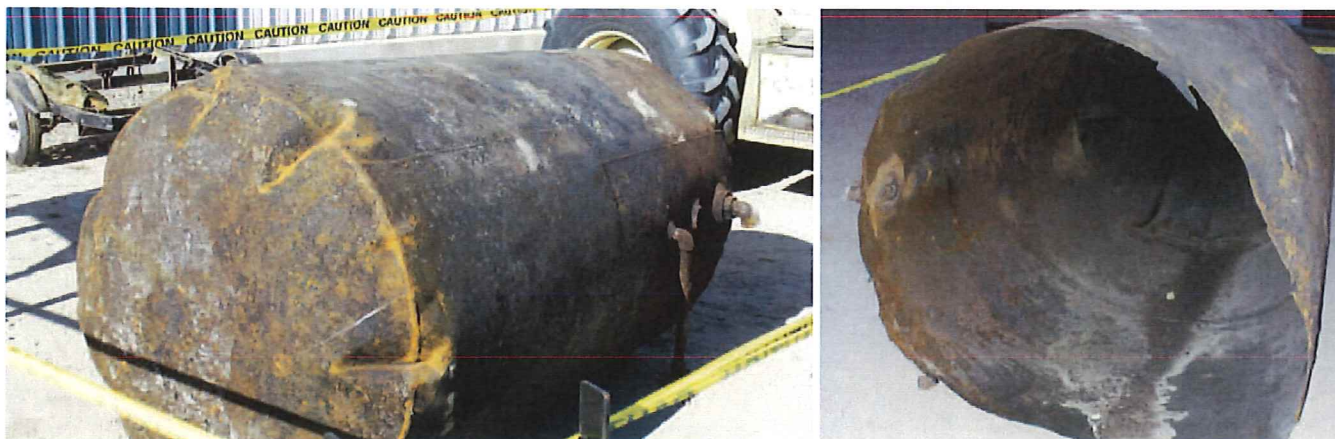
Exterior and interior views of the fuel tank involved in the hot work accident at A.V. Thomas Produce.

Two employees at A.V. Thomas Produce were using an oxygen-acetylene torch to loosen a fitting on an old fuel tank, which the company hoped to refurbish for field storage of diesel fuel. The workers, however, were unaware that the tank contained residual hydrocarbon liquid and vapor from an unknown prior use. The tank was not cleaned or purged before work began. Shortly after applying heat to the tank, an explosion occurred, blowing the end of the vessel off. Both employees were airlifted to a regional burn center, where they were treated for burns covering 30 to 50% of their bodies.

The facility had no formal hot work program, and no permit was issued for the hot work being performed. No combustible gas testing was performed prior to commencement of the hot work; the company did not have a policy that required it. In addition, many workers were mono-lingual Spanish speakers and had not been trained on safe hot work procedures or on the proper use of gas detectors in their native language.

Analyze the Hazards, Monitor the Atmosphere,  
Test the Area, Use Written Permits, Train Thoroughly

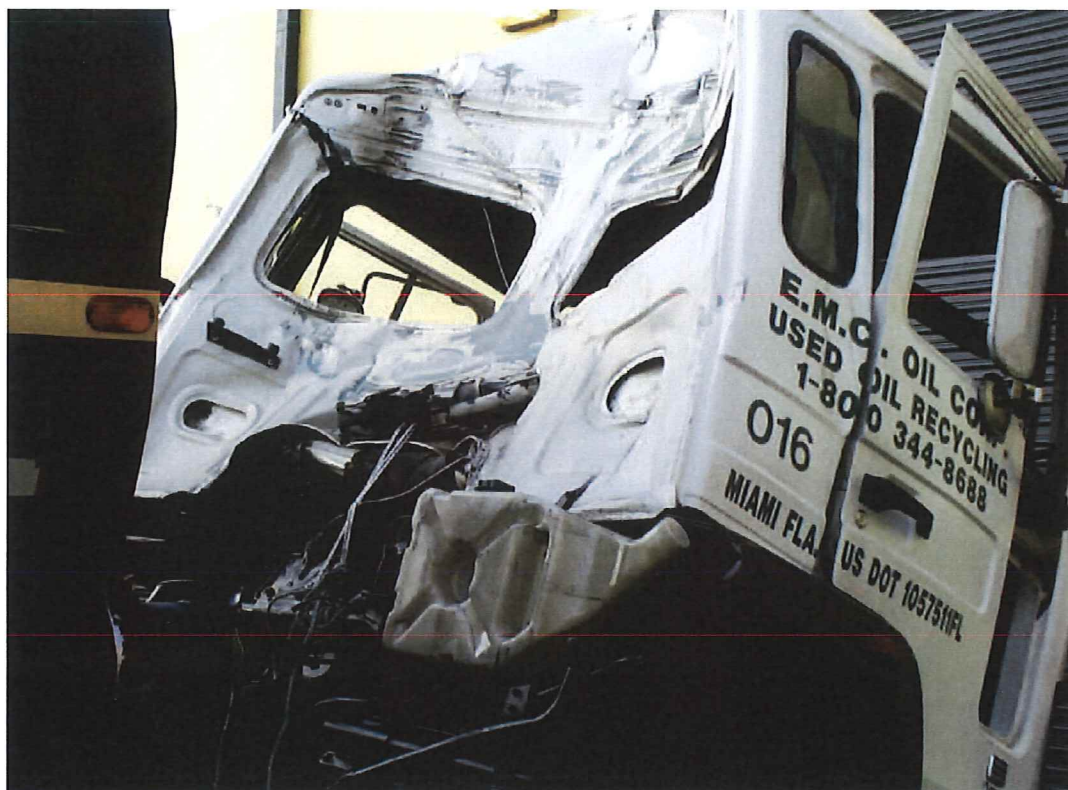
Damage to an oil tanker sustained from the December 2, 2008, explosion at EMC Used Oil Corporation.

An explosion killed a contract welder who was repairing a two-compartment oil tanker and injured another worker at the EMC Used Oil facility. The welder was in the process of welding transfer piping onto the tanker when residual hydrocarbon vapor from the 2,500-gallon rear compartment ignited, causing a powerful explosion.

The surviving worker stated that the contractors did not perform combustible gas monitoring and relied upon the host company to assure that tanks were safe for hot work. However, EMC indicated that it relied on contractors to monitor for gas; although the company owned a multiple gas detector, it was used only for confined space entry. EMC did not have a formal hot work permitting or authorization system.

Use Alternatives, Analyze the Hazards, Monitor the Atmosphere, Test the Area, Use Written Permits, Supervise Contractors

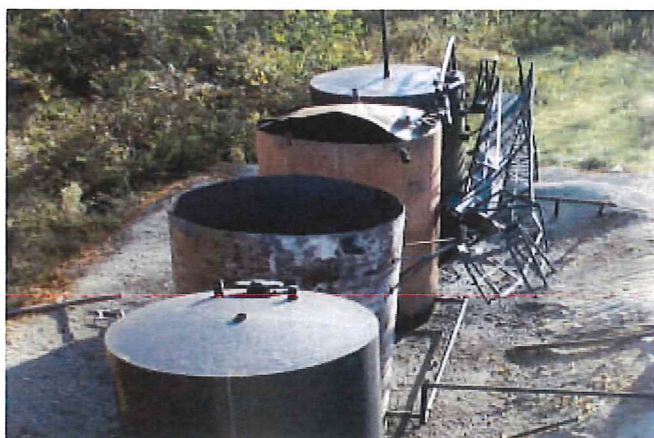
Oil storage tanks involved in fire and explosion at MAR Oil.

An explosion killed two contract workers while they were welding above a series of three interconnected crude oil storage tanks at a MAR Oil site. The explosion occurred when the workers attempted to weld a bracket on top of one of the tanks, near an atmospheric vent. Because the tanks were interconnected, oil flowing into an adjacent tank likely displaced flammable vapor into the tank being welded. The vapor escaped through the vent and was ignited by welding sparks.

The CSB investigators found that combustible gas monitoring was not performed prior to or during the welding. There is conflicting evidence as to whether or not the welding job was authorized by the host company. MAR Oil lacked a formal hot work program that required the hot work be identified in a written permit and be authorized by a person responsible for hot work management. The company had no formal program to select or oversee contractors, and the two contractors lacked documented training on safe hot work practices.

Use Alternatives, Analyze the Hazards, Monitor the Atmosphere, Test the Area, Use Written Permits, Train Thoroughly, Supervise Contractors

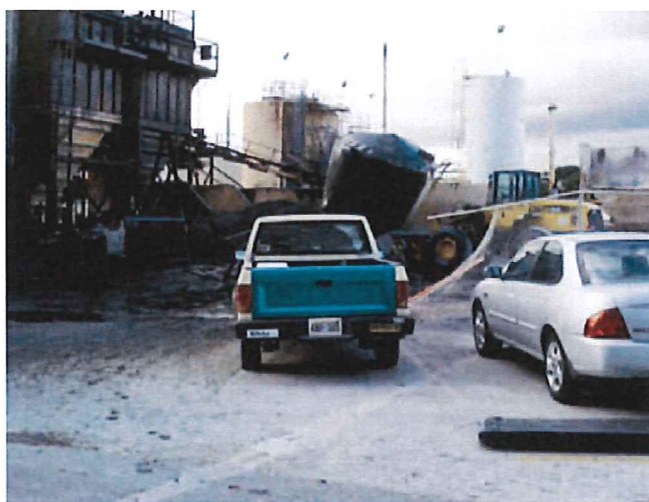
A contract welder was killed while welding on a catwalk located over a 9,300-gallon waste oil storage tank at the Philip Services Corporation (PSC). Following an investigation, the Honolulu Fire Department (HFD) concluded that, during the welding, sparks dropped in and around the vent area of the tank. The contents of the tank ignited, resulting in an explosion and fire. The force of the explosion hurled the contract welder about 120 feet, fatally injuring him. Three others were injured, and the tank was thrown about 30 feet.

According to the HFD investigation, a PSC official asserted that the contractors were not authorized to weld within the dike area surrounding the tank, a hot work permit had not been issued for the welding, and combustible gas monitoring was not conducted. Conversely, the contracting company's personnel asserted that they believed that the work was authorized and that PSC had conducted combustible gas monitoring prior to the welding activity.

View of Philip Services Corporation following a October 7, 2008, waste oil storage tank explosion.

Use Alternatives, Analyze the Hazards, Monitor the Atmosphere, Test the Area, Use Written Permits, Supervise Contractors

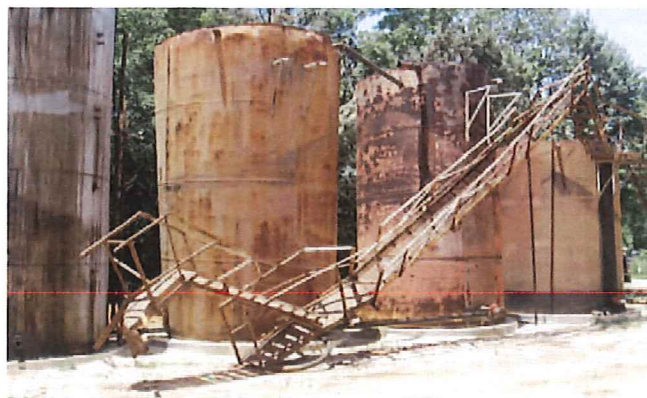
On June 5, 2006, contract workers were installing a new pipe between two oil tanks at a rural oilfield when sparks from a welding torch ignited flammable hydrocarbon vapor venting from one of the tanks. That tank and another nearby tank exploded, killing three workers who were standing above the tanks and seriously injuring a fourth. As in the MAR Oil accident, all of the tanks were interconnected by piping and one of the tanks contained crude oil, the source of the vapor that fueled the explosions.

The workers had not performed combustible gas monitoring prior to or during the hot work, instead relying on the unsafe and unreliable practice of using a lit torch to check one of the tanks for flammable vapor. Workers did not empty or isolate the tank that contained crude oil prior to initiating hot work activities.

Neither the contract company nor Partridge-Raleigh required written hot work permits. The contractor company did not provide hot work safety training to employees. Furthermore, Partridge-Raleigh did not have safety requirements for its oilfield contractors.

Tanks involved in the 2006 accident that killed three workers at the Partridge-Raleigh Oilfield.

Use Alternatives, Analyze the Hazards, Monitor the Atmosphere, Test the Area, Use Written Permits, Train Thoroughly, Supervise Contractors

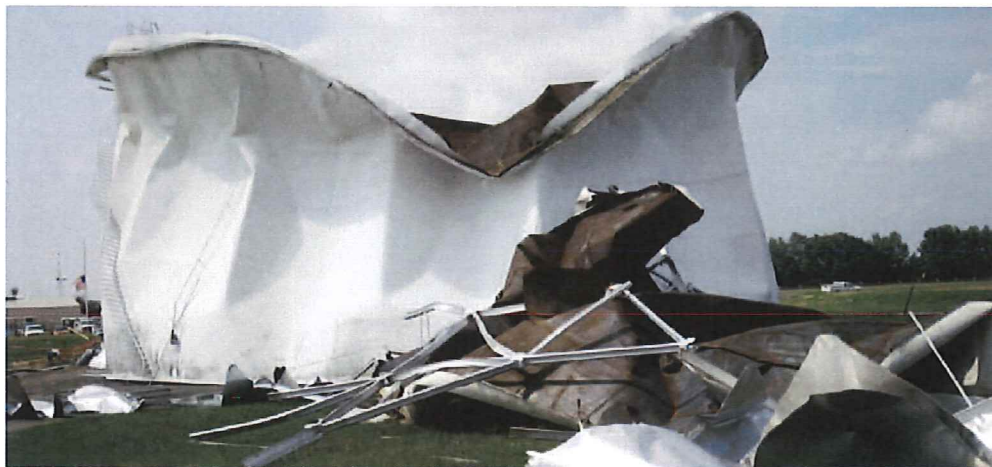
The gasoline storage tank at the TEPPCO McRae Terminal following the 2009 hot work accident that killed three workers.

Three contractors were using a cutting torch on top of the internal floating roof of a 67,000-barrel capacity gasoline storage tank at the TEPPCO Partners McRae Terminal when an internal explosion blew both the top of the floating roof and the secondary dome-shaped lid off the tank. All three were killed. The contractors were preparing to install a gauge pole. The gauge floats within the pole and measures the quantity of product within the tank. Part of the installation process involved cutting an opening into the floating roof for the pole to be inserted. The torch-cutting activity most likely ignited flammable vapor within the tank.

work permit to torch-cut the roof. The hot work permit indicated that gas testing occurred at 7:00 am, the start of the work shift. However, no documentation exists indicating that gas testing was conducted after the workers returned from lunch or when they started the hot work activities just prior to the explosion at approximately 2:30 pm. Work atmospheres can change rapidly; gas monitoring needs to be conducted immediately prior to and during hot work activities to ensure that workers are constantly aware of the potential development of an explosive atmosphere.

Analyze the Hazards, Monitor the Atmosphere,  
Test the Area, Supervise Contractors

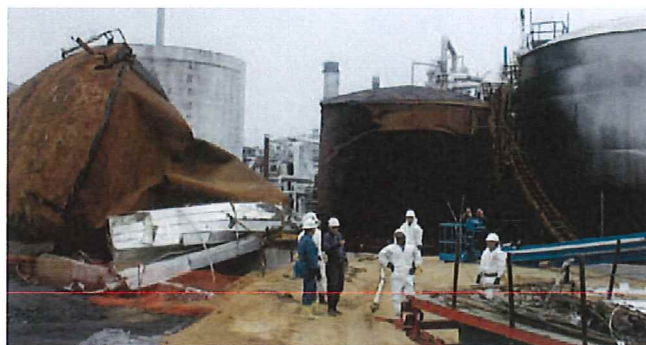
A massive explosion destroyed a large storage tank containing a mixture of sulfuric acid and flammable hydrocarbons at the Motiva Enterprises Delaware City Refinery. One contract worker was killed, eight others were injured, and sulfuric acid from collapsed and damaged tanks polluted the Delaware River. The explosion occurred during welding operations to repair a catwalk above the sulfuric acid tank, when flammable hydrocarbon vapor was ignited by welding sparks. This resulted in a powerful explosion inside the tank, which had holes in its roof and shell and a deficient inerting system.

On the day of the accident, combustible gas testing was performed only at the start of the hot work, but monitoring was not conducted for the duration of the hot work activities. Throughout the five hours between the last gas test and the explosion, the ambient temperature warmed by 14 degrees. This warming increased the evaporation of hydrocarbons inside the tank, and the resulting flammable vapor leaked out the tank's holes into the work area.

Motiva had a hot work program that included written permits, but the program was inadequate. Hot work was allowed near tanks that contained flammables including

A view of the flammable storage tank involved in the accident at the Motiva Refinery.

those that had known holes due to corrosion. Continuous atmospheric monitoring and the control of welding sparks were not required.

Use Alternatives, Analyze the Hazards, Monitor the Atmosphere, Test the Area, Supervise Contractors
